Annie
5 y/o
Toy Poodle

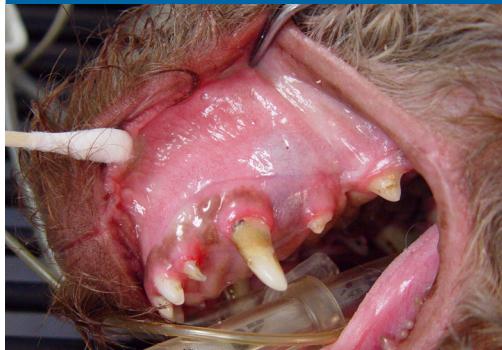
Invisible from the outside, this dog presented with a maxillary cyst that is destroying the facial bones that support the nasal cavities (fossae).

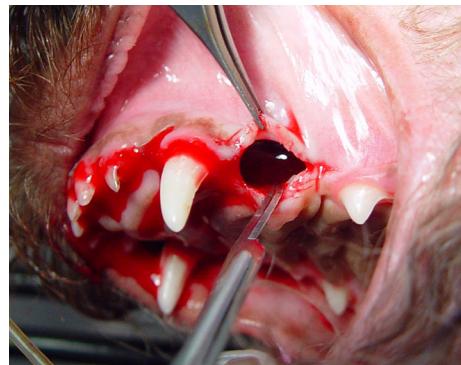
Incision into the soft tissue slowly exposes the cyst.

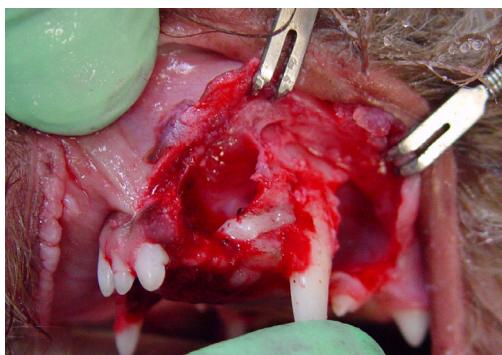
The destructive nature of the maxillary cyst is fully exposed.

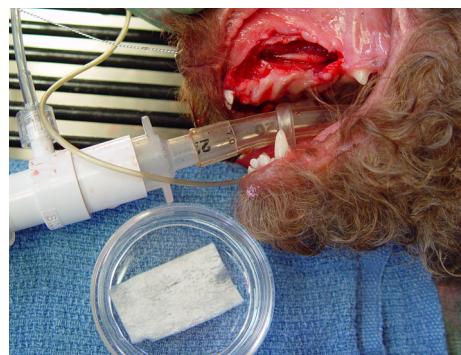
A freeze-dried **Ossiflex® Bone Membrane** is rehydrated with saline. A sterile swab is placed into the nasal fossa to guide the membrane placement.

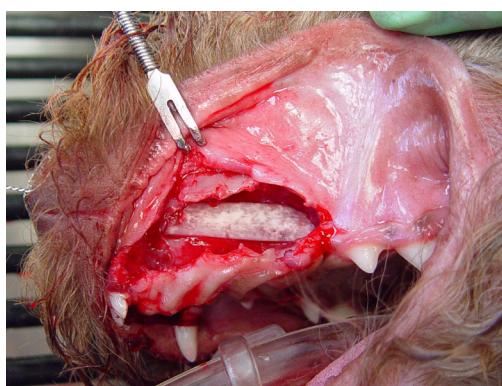
The **Ossiflex® Bone Membrane** is secured to protect the ventral nasal meatus.

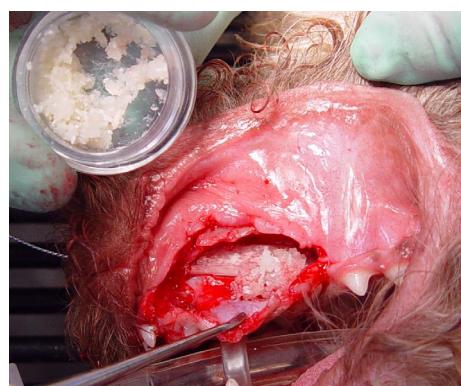
Osteoallograft® Periomix® is applied into the defect as a graft to rebuild the hard palate, alveolar, and incisive bone.

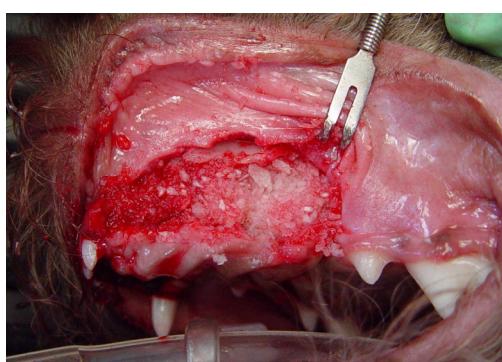
The defect is completely filled with **Osteoallograft® Periomix®** to achieve maximal bone regeneration.

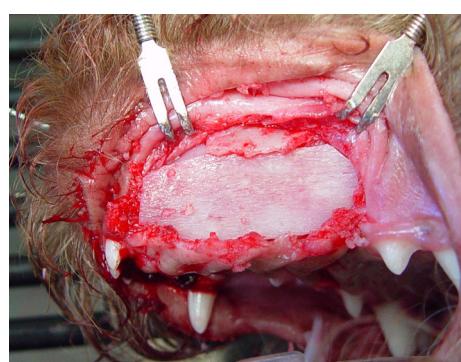
For Guided Bone Regeneration, the particulate bone graft is covered with an **Ossiflex® Bone Membrane** to avoid premature in-growth of soft tissue.

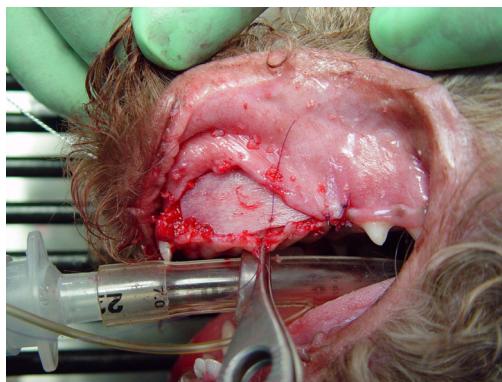
The bone membrane is sutured in place and soft tissue is sutured closed.

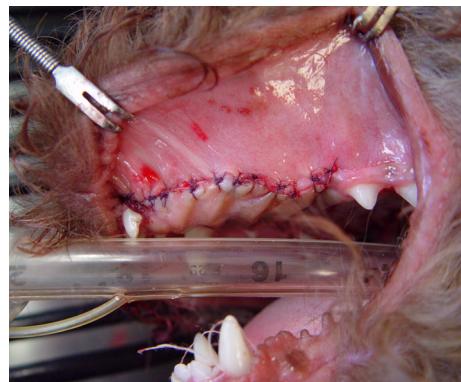
Sutures are in place and the surgery is complete.

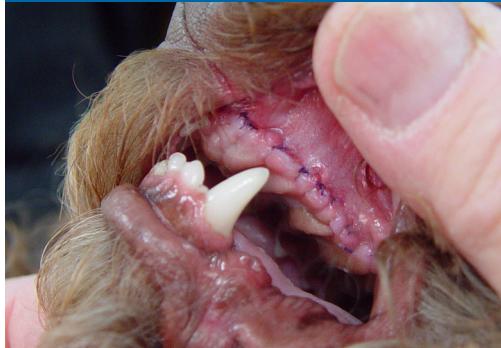
**3 DAY
POST OP:**

At a 3-day follow-up visit, the surgical site remains in good condition.

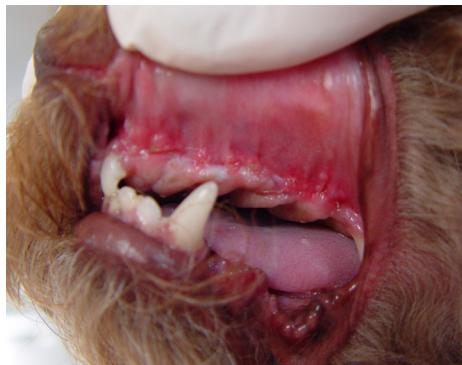
**6 WEEK
POST OP:**

Site appears nicely healed and maxillary bone is palpably solid.

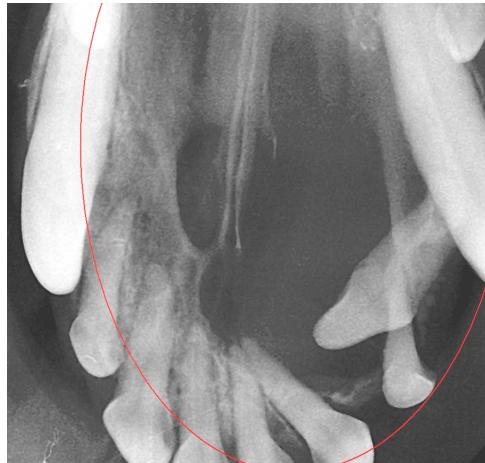
PRE OP:

The occlusal radiograph shows the size and scope of the cyst.

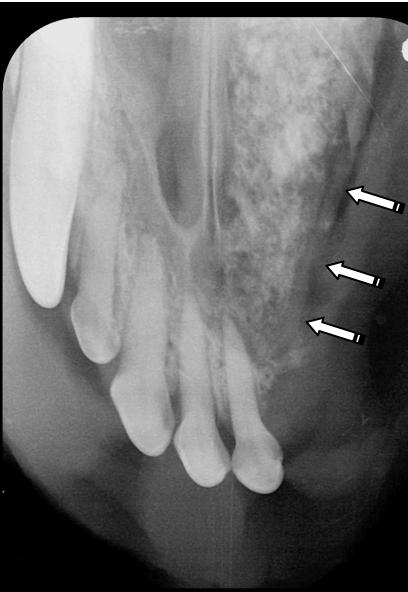
POST OP:

The particulate graft is retained by the demineralized Ossiflex Membrane (arrows).

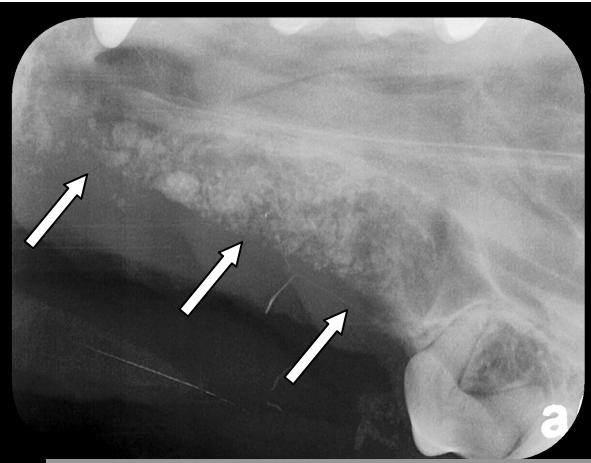
**6 WEEK
FOLLOW UP:**

At 6 weeks, the Palatine Fossa is slowly becoming visible (arrow). Ossiflex is still functioning to retain the mineralizing Periomix.

Architectural remodeling and new bone around incisors is evident.

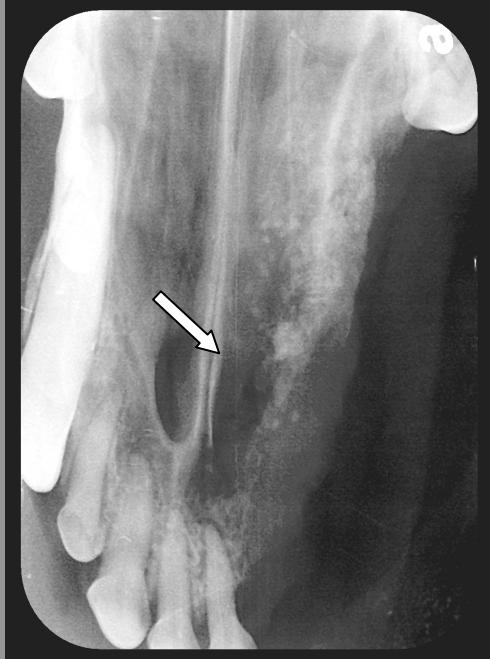
**6 MONTH
FOLLOW UP:**

The six month follow-up radiograph shows that the bone is regenerating to form the structural foundation of the Palatine fossa.

The dog is breathing normally.
