## VTS Osteoallograft Periomix Case 7

## Dental Implant

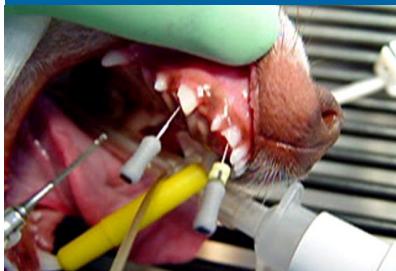
2.5 year-old Chihuahua mix presented with face trauma creating a canine and incisor fracture with pulp exposure. Also note a deformed lateral incisor.

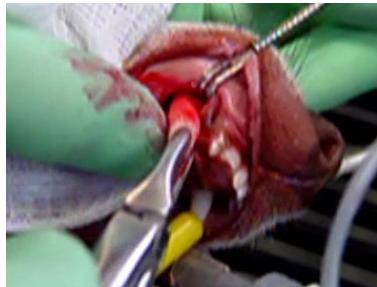
All involved teeth were atraumatically extracted to preserve as much alveolar bone as possible.

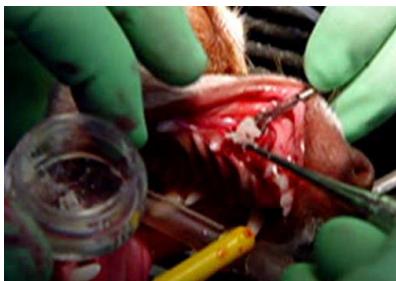
The extraction site is filled with **Osteoallograft® Periomix®**.

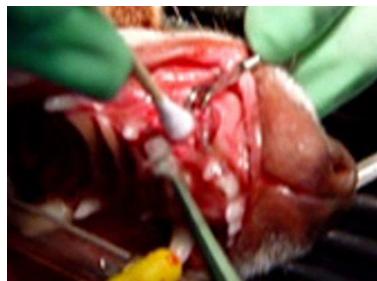
The bone allograft is compacted into the apical area of the alveolus to ensure complete and dense filling.

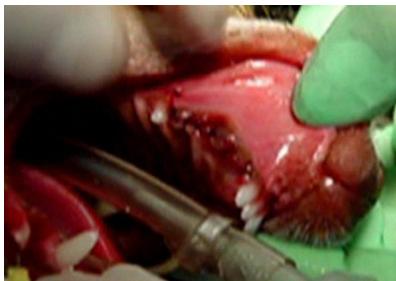
After all affected teeth were surgically extracted and grafted, the gingival flap has been sutured closed.

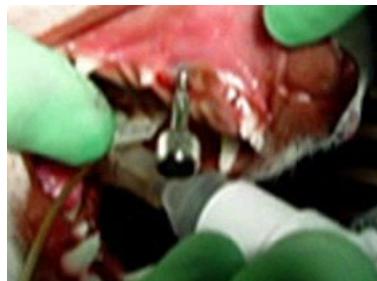
12 weeks after placement of the **Osteoallograft® Periomix®** bone allograft, radiographs show dense bone ready for two mini implants to be seated.

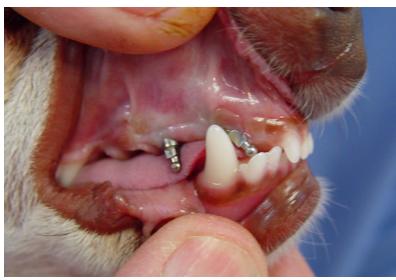
24 weeks after the extractions, the implants are immobile and ready for the impressions.

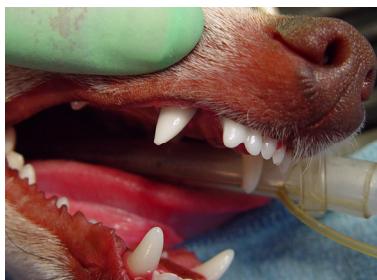
The canine pontic and a 2-unit bridge are cemented onto the abutments. They are beautiful and – most importantly – rock solid.

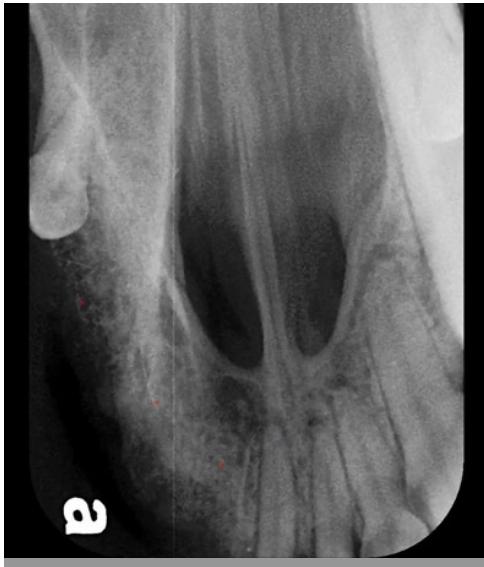
### POST OP:

Extraction sites are filled with **Osteoallograft® Periomix®**.

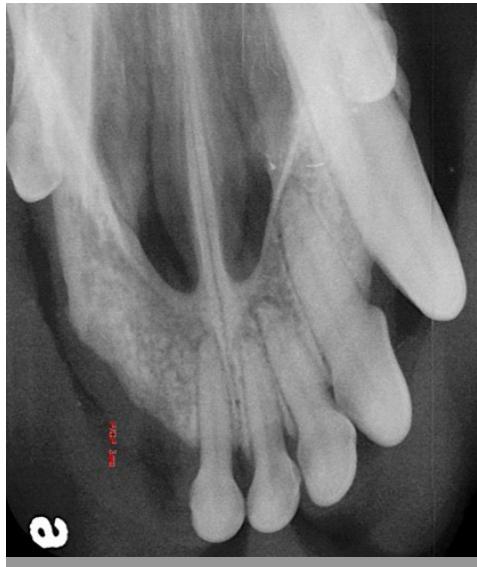
### 12 WEEK FOLLOW UP:

At 12 weeks, the radiograph shows dense bone. Says Dr. Mele, "We are into very, very good bone [suitable for implants]."

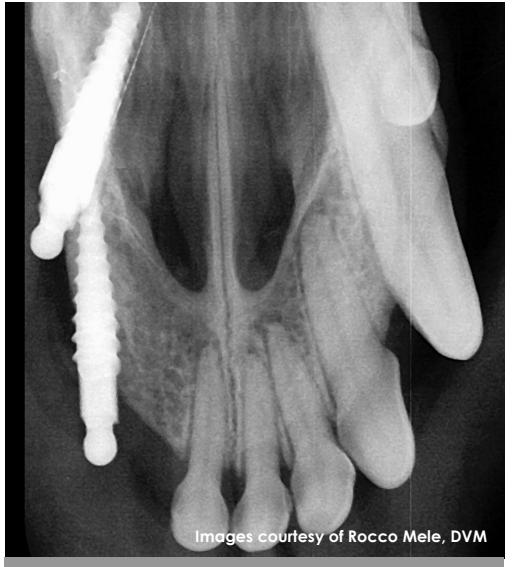
### 24 WEEK FOLLOW UP:

At the 24 week follow-up, the implants are anchored into the maxilla and ready for bridge placement.
