# VTS Cancellous Bone Block Case

## Large Extraction Site

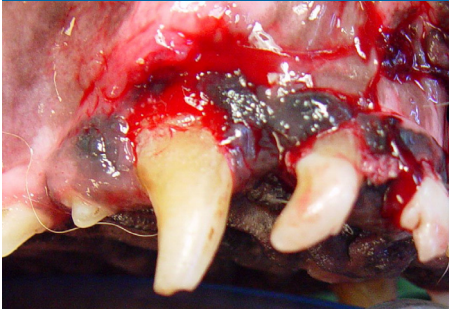
11 year-old Australian Shepherd named Rosie presented with a fractured canine, gingival edema and deep palatal infrabony pockets.

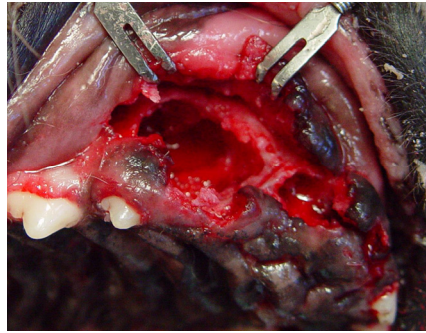
Only after affected teeth were extracted and the inflammatory tissue was removed from the socket, could the extensive damage to the alveolar bone be seen.

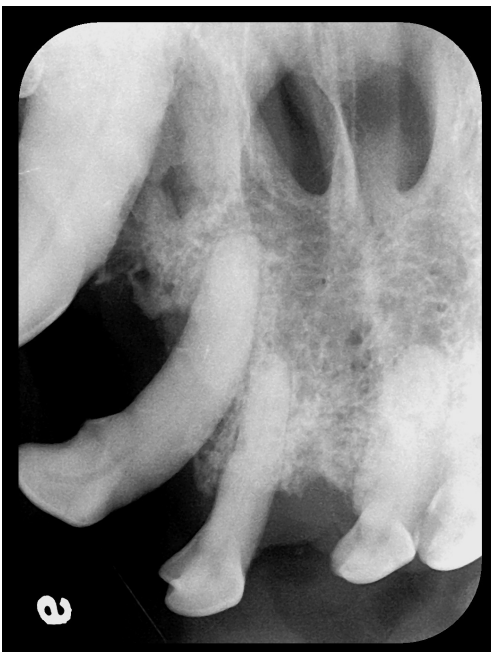
### PRE OP:

The pre-op radiograph shows bone loss resulting from necrosis of the supporting bone. Note the nasal fistula tract.

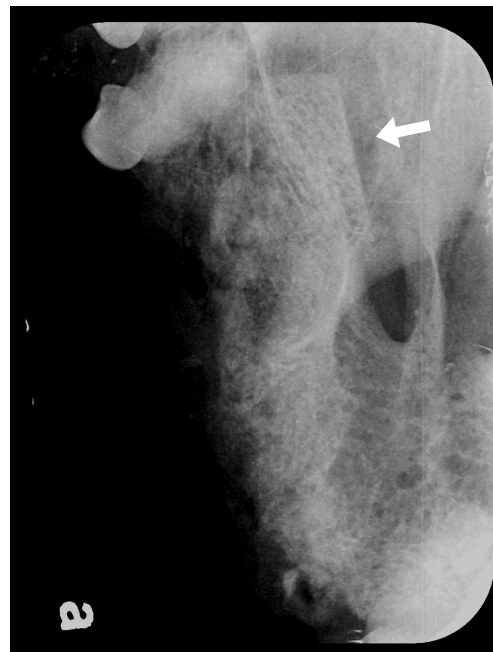
### POST OP:

The post-op radiograph shows the margins of the cancellous bone block allograft in the extraction site surrounded by **Osteoallograft® Periomix®**.

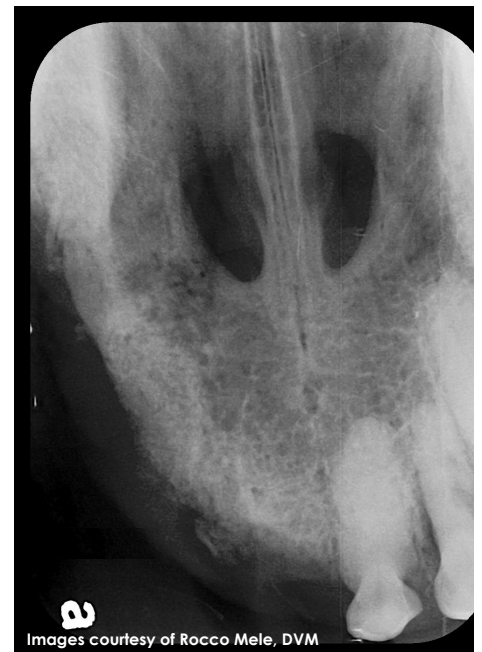
### 4 WEEK FOLLOW UP:

At only 4 weeks post surgery, the cancellous block appears fully integrated into the host bone and bone density has significantly improved.
